**Report on the preliminary  
fact finding mission  
following the accident at the  
nuclear fuel processing  
facility in Tokaimura, Japan**

INTERNATIONAL ATOMIC ENERGY AGENCY, VIENNA, 1999

REPORT ON THE PRELIMINARY  
FACT FINDING MISSION  
FOLLOWING THE ACCIDENT AT THE  
NUCLEAR FUEL PROCESSING FACILITY  
IN TOKAIMURA, JAPAN

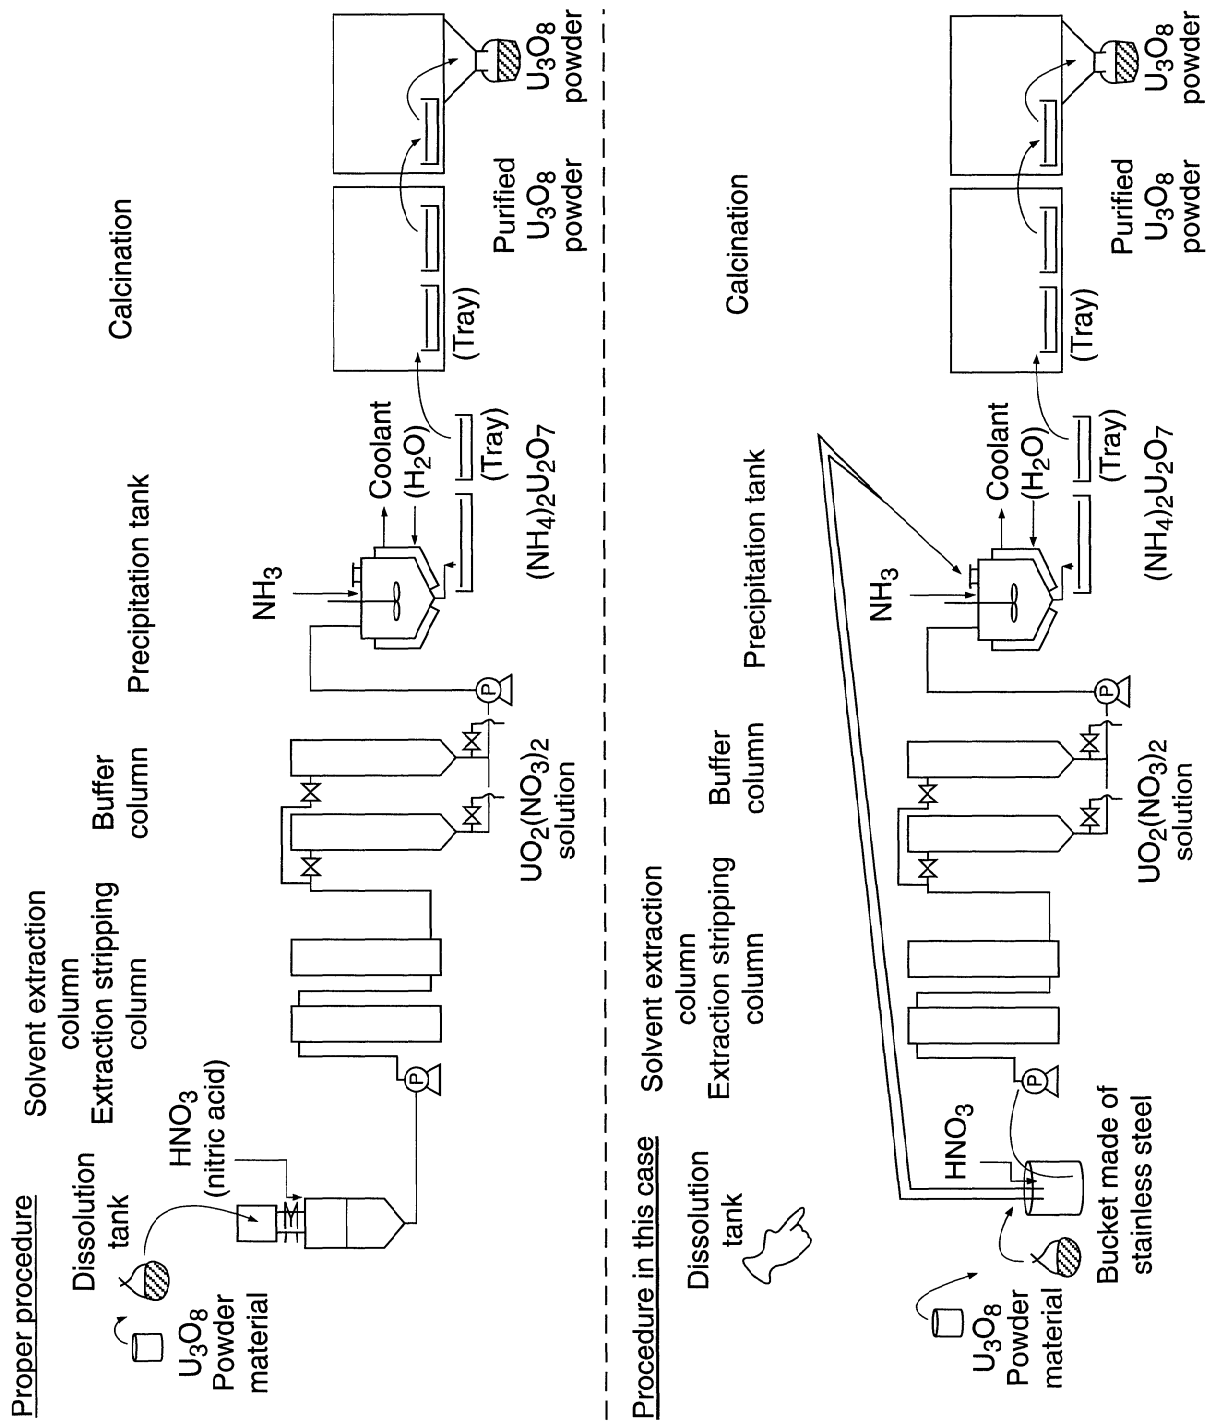
The work procedure was modified in November 1996, without permission for the modification having been given by the regulatory authorities, to allow the dissolution of uranium oxide ( $U_3O_8$ ) to be performed in stainless steel buckets. According to the information provided at the meetings with the IAEA Secretariat team, this new procedure had been followed several times before this accident occurred.

Furthermore, when the criticality event occurred, homogenization of uranium oxide was being performed by mechanical stirring in the precipitation tank instead of in the mass control equipment. This was done by pouring uranyl nitrate solution (made by dissolving uranium oxide ( $U_3O_8$ ) in nitric acid) directly from the steel bucket into the precipitation tank. The tank was not designed with a geometry conducive to preventing criticality, being 450 mm in diameter and 610 mm high (Fig. 8). This means of homogenization in the precipitation tank is not even described in the revised procedure and was a further deviation from the approved procedure.

buckets and poured the solution directly into the precipitation tank. About 26 L of the solution, with uranium enriched to 18.8%  $^{235}U$  by mass, had been poured into the precipitation tank in four batches on 29 September. In the morning of 30 September, the workers continued to prepare uranyl nitrate solution and poured three additional batches into the precipitation tank (Figs 7 and 8).

Fig. 7. Schematic diagram of the proper procedure and the actual procedure used in this case for dissolution and precipitation.

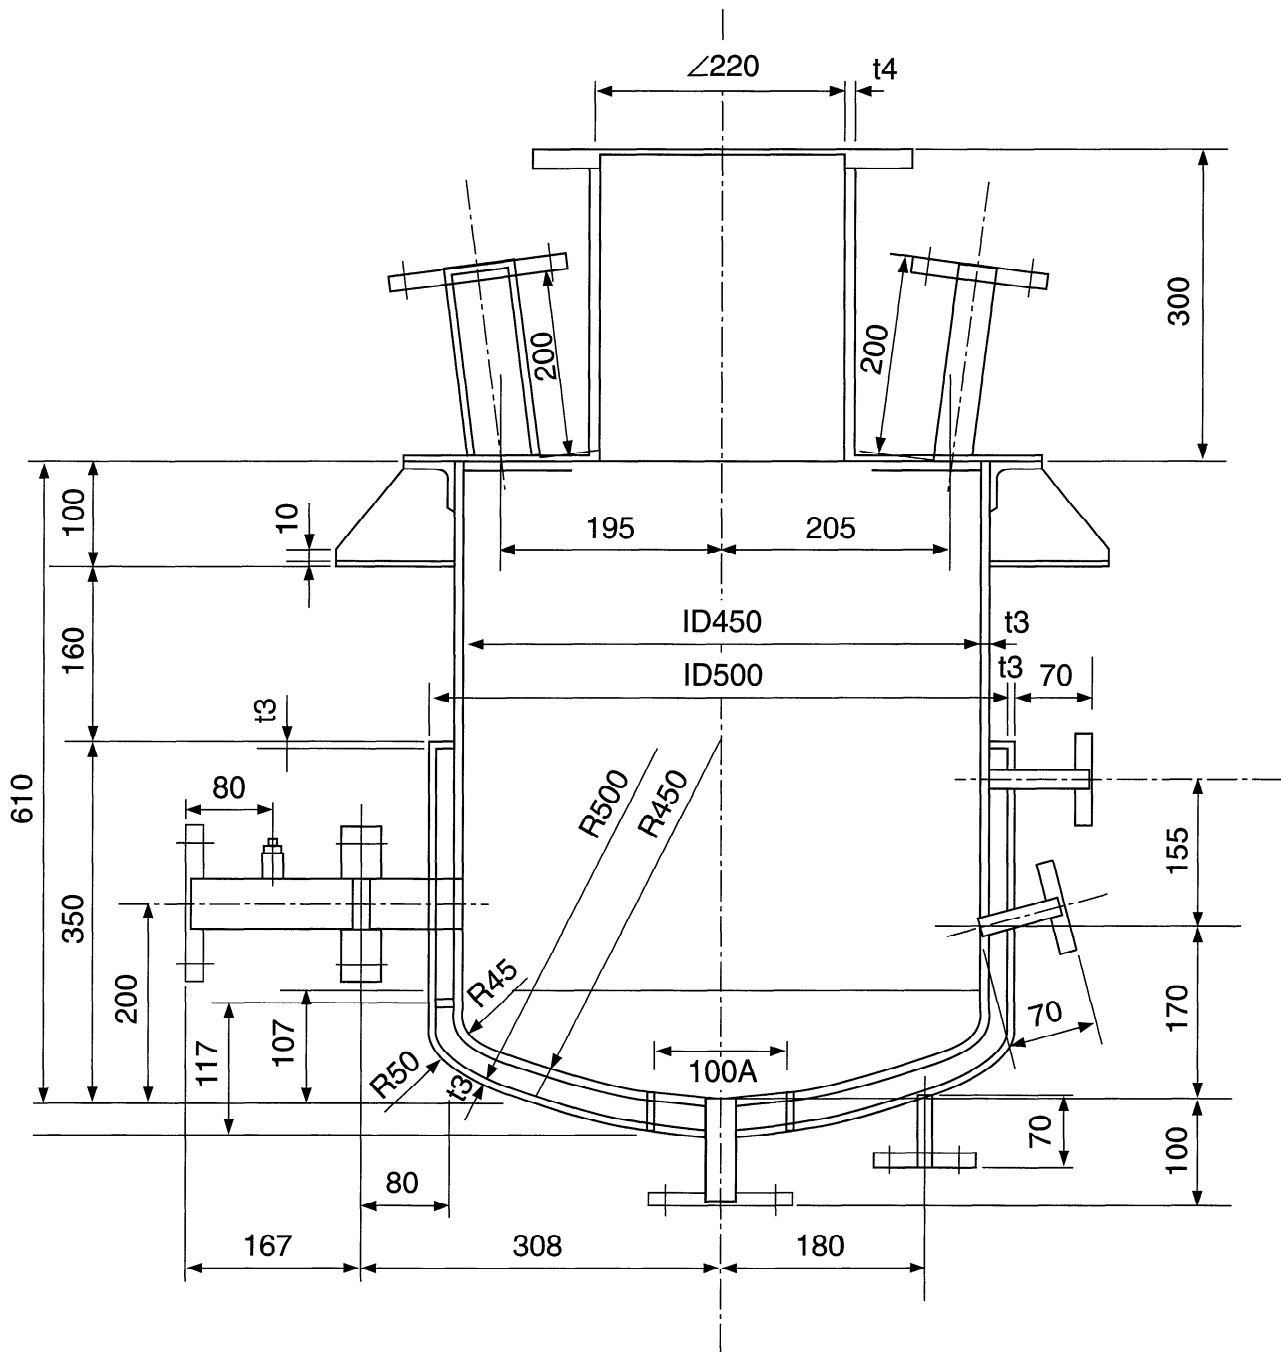
Fig. 8. Cross-section of the precipitation tank indicating dimensions (in mm).

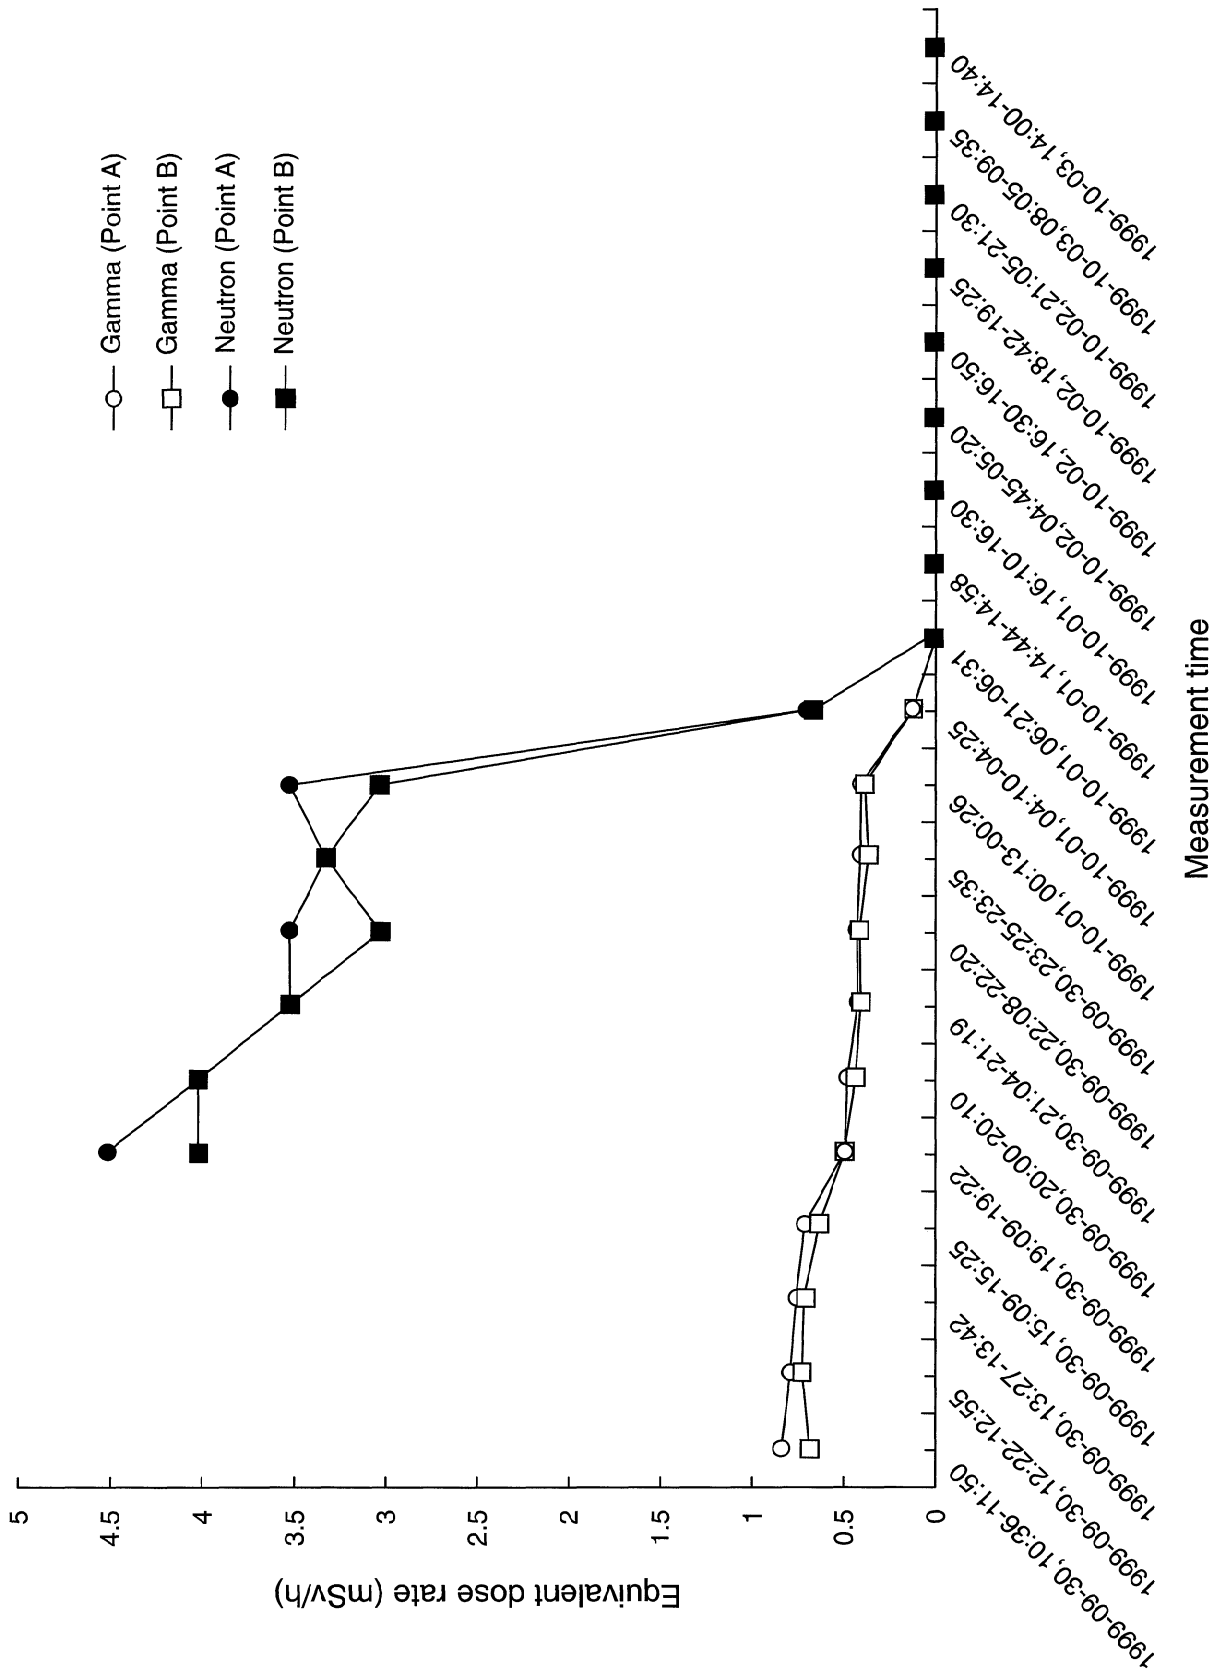
At 11:40, a maximum gamma dose rate of 0.84 mSv/h was measured in an area around the facility [4, 13, 14] (Fig. 9). At around 14:00, the Mito Atomic Energy Office of STA started monitoring gamma dose rates. The results were provided to the LCH and to the Government Accident Countermeasures Headquarters (GACH) which had been established at 15:00.

After 17:00, the maximum neutron dose rates at the site boundaries were measured to be around 4 mSv/h (Fig. 9), which indicated a continuing state of criticality [4, 13].

Fig. 9. Gamma and neutron dose rates at monitoring points A and B (see Fig. 4).

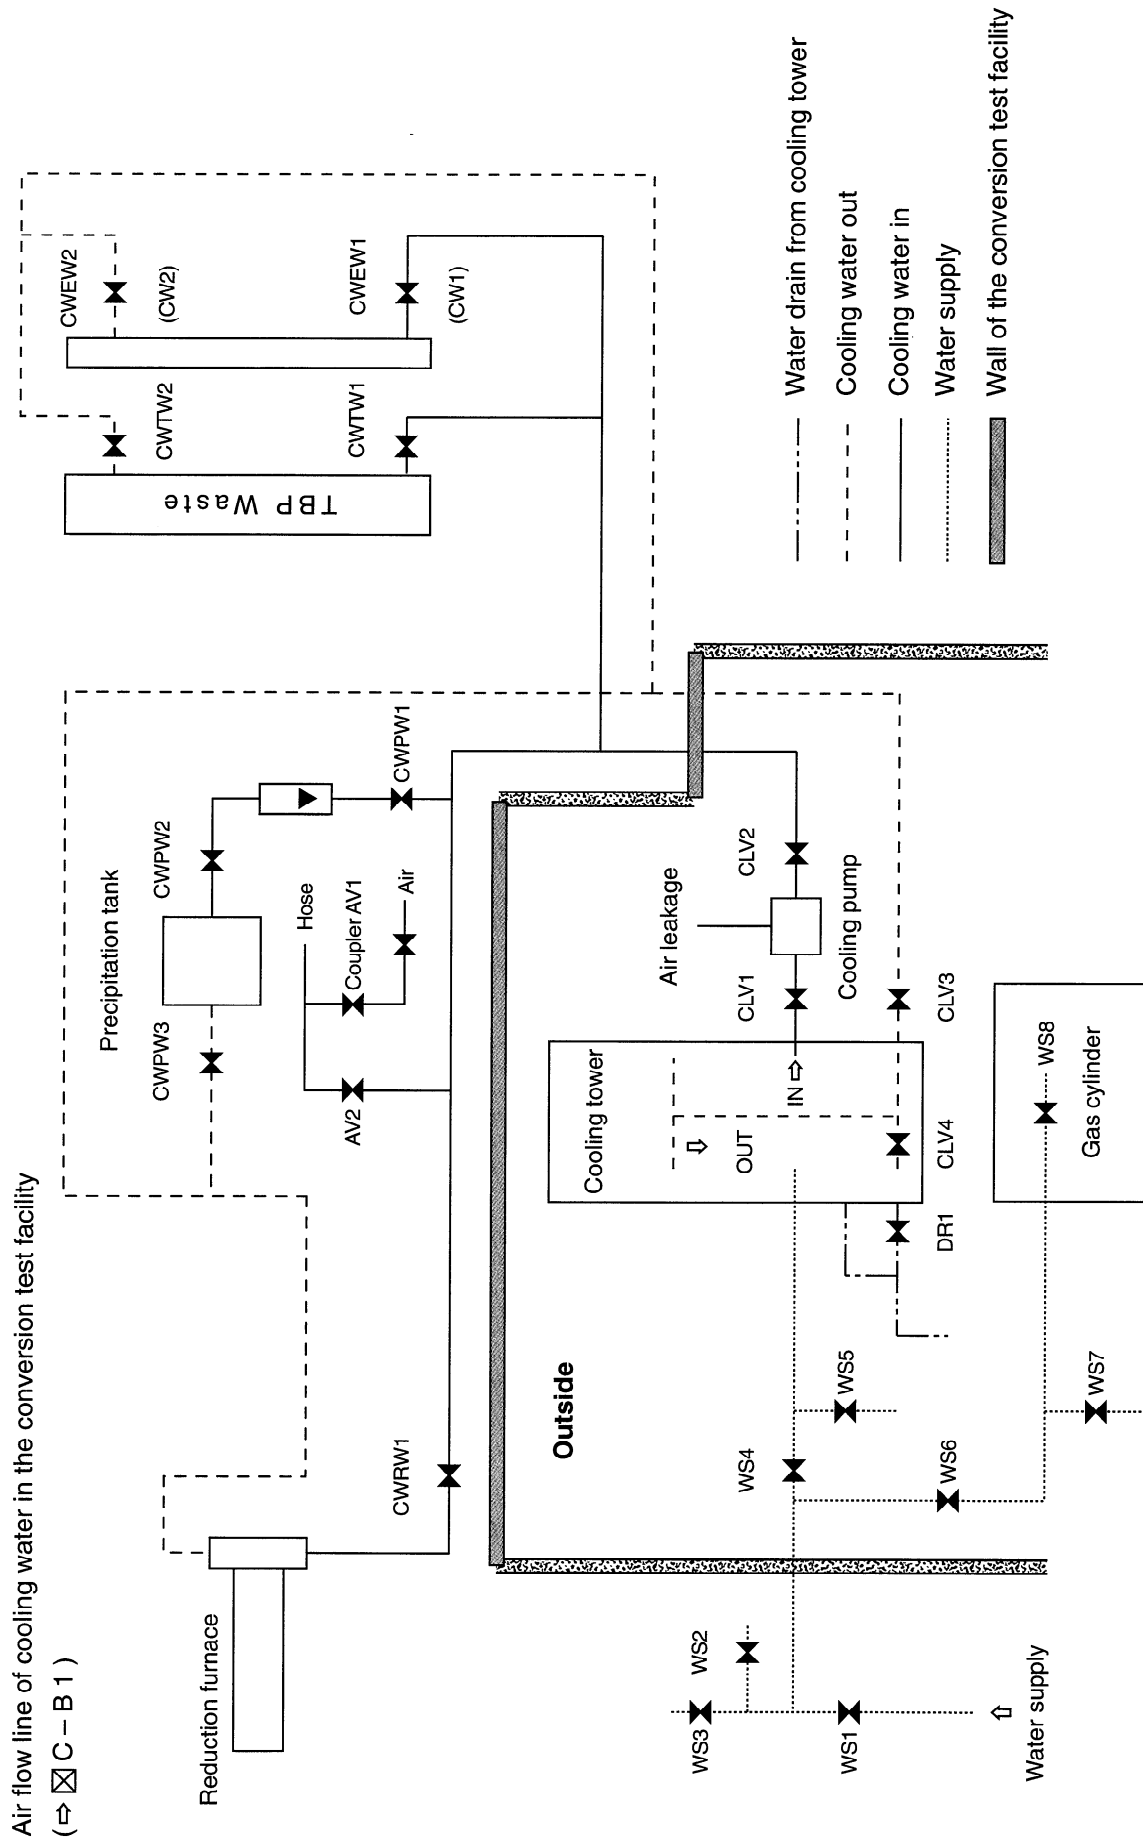
removal of water from the cooling jacket could help to terminate the state of criticality. The cooling jacket acted as a neutron reflector, thereby enhancing nuclear fission [14]. At the second meeting at the GACH, held at 23:15 on 30 September, it was concluded that the cooling water should be drawn off from the water jacket surrounding the precipitation tank in order to end the state of criticality and thereby terminate the self-sustaining nuclear chain reaction [13].

Fig. 10. Schematic diagram of the cooling system for the conversion building (TBP: tributyl phosphate).

The cooling pump, the valves and the cooling tower were located outside the building, making them easier to access (Fig. 10). Attempts to drain the water were made between 02:35 and 06:04 on 1 October. Ten approaches were made, the purpose of the first being to photograph the cooling tower and pump area. First the cooling tower feed valve (WS4 in Fig. 10) was closed and the drain valve (DR1 in Fig. 10) was opened. At this stage, only a little water was drained, but the neutron dose rate decreased somewhat. The water pipe was then broken and cut to drain the water. Finally, at around 06:15, argon gas was pumped into the water pipe to force out much more water. At around 06:30 the neutron dose rate was below the detection limit [14] (Fig. 11).

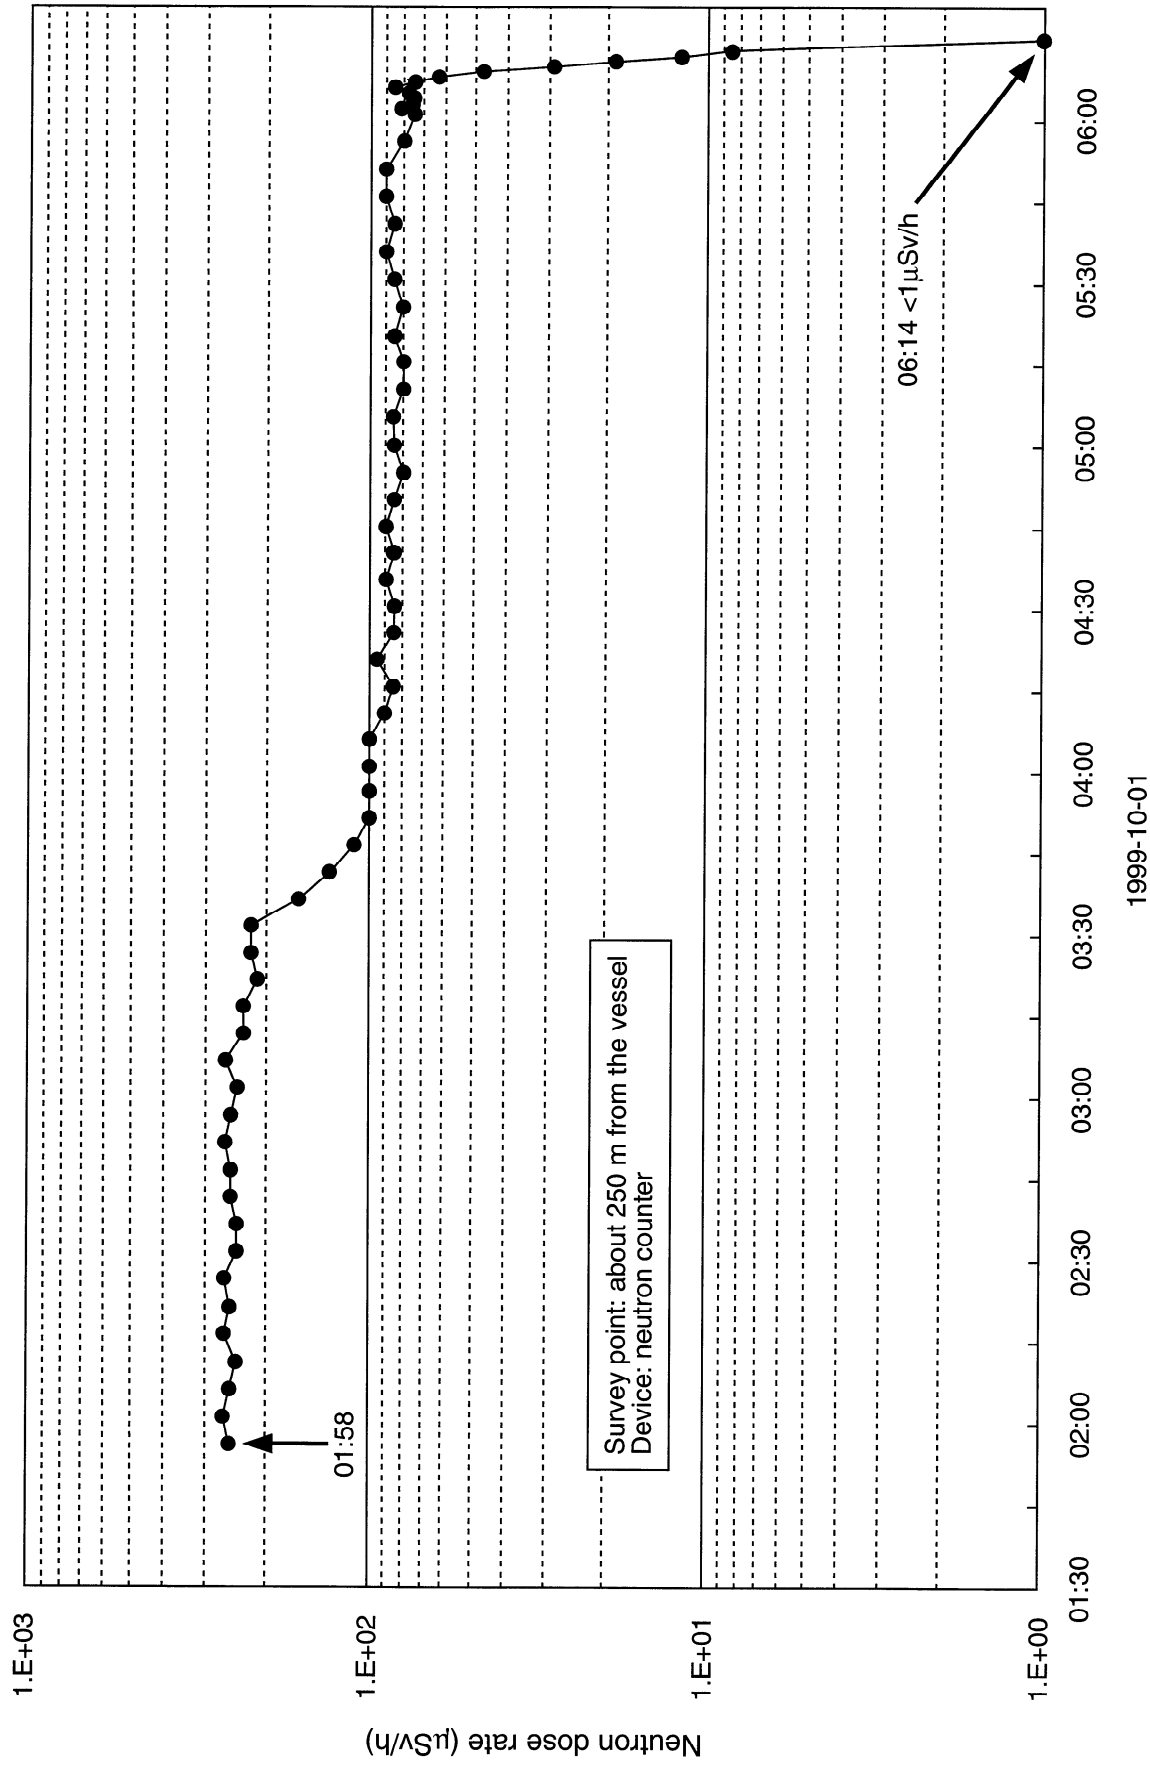
Fig. 11. The trend of neutron dose rate during mitigation (measured by JNC).

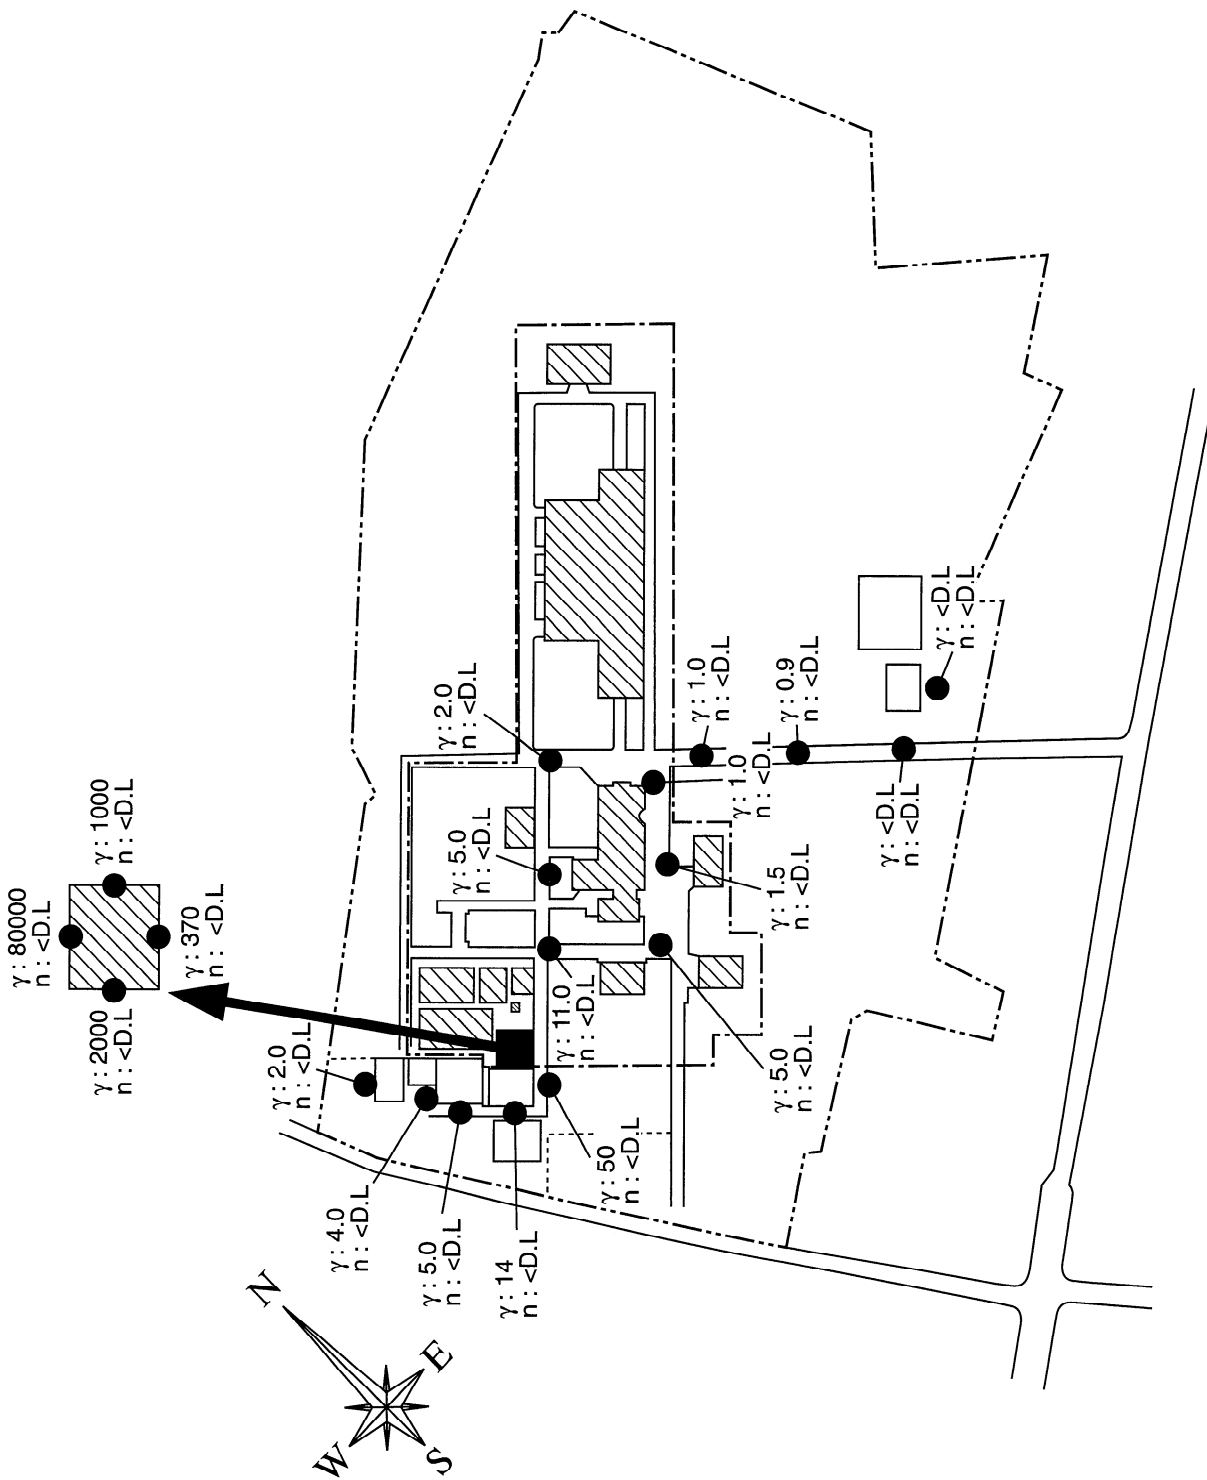
- With regard to the remaining radiation fields, gamma radiation dose rate measurements were performed at 06:20 on 1 October. These measurements yielded gamma dose rates of several millisieverts per hour close to the building and several microsieverts per hour at the boundary of the site (Fig. 12). Shielding material such as sandbags were placed around the building on the morning of 2 October (Fig. 13). Walls made of concrete shielding material were assembled in some places around the facility (Fig. 14).

Fig. 12. Gamma and neutron dose rates after the end of criticality (units:  $\mu\text{Sv/h}$ ). The measurements were made by JNC at 06:20 on 1 October 1999.

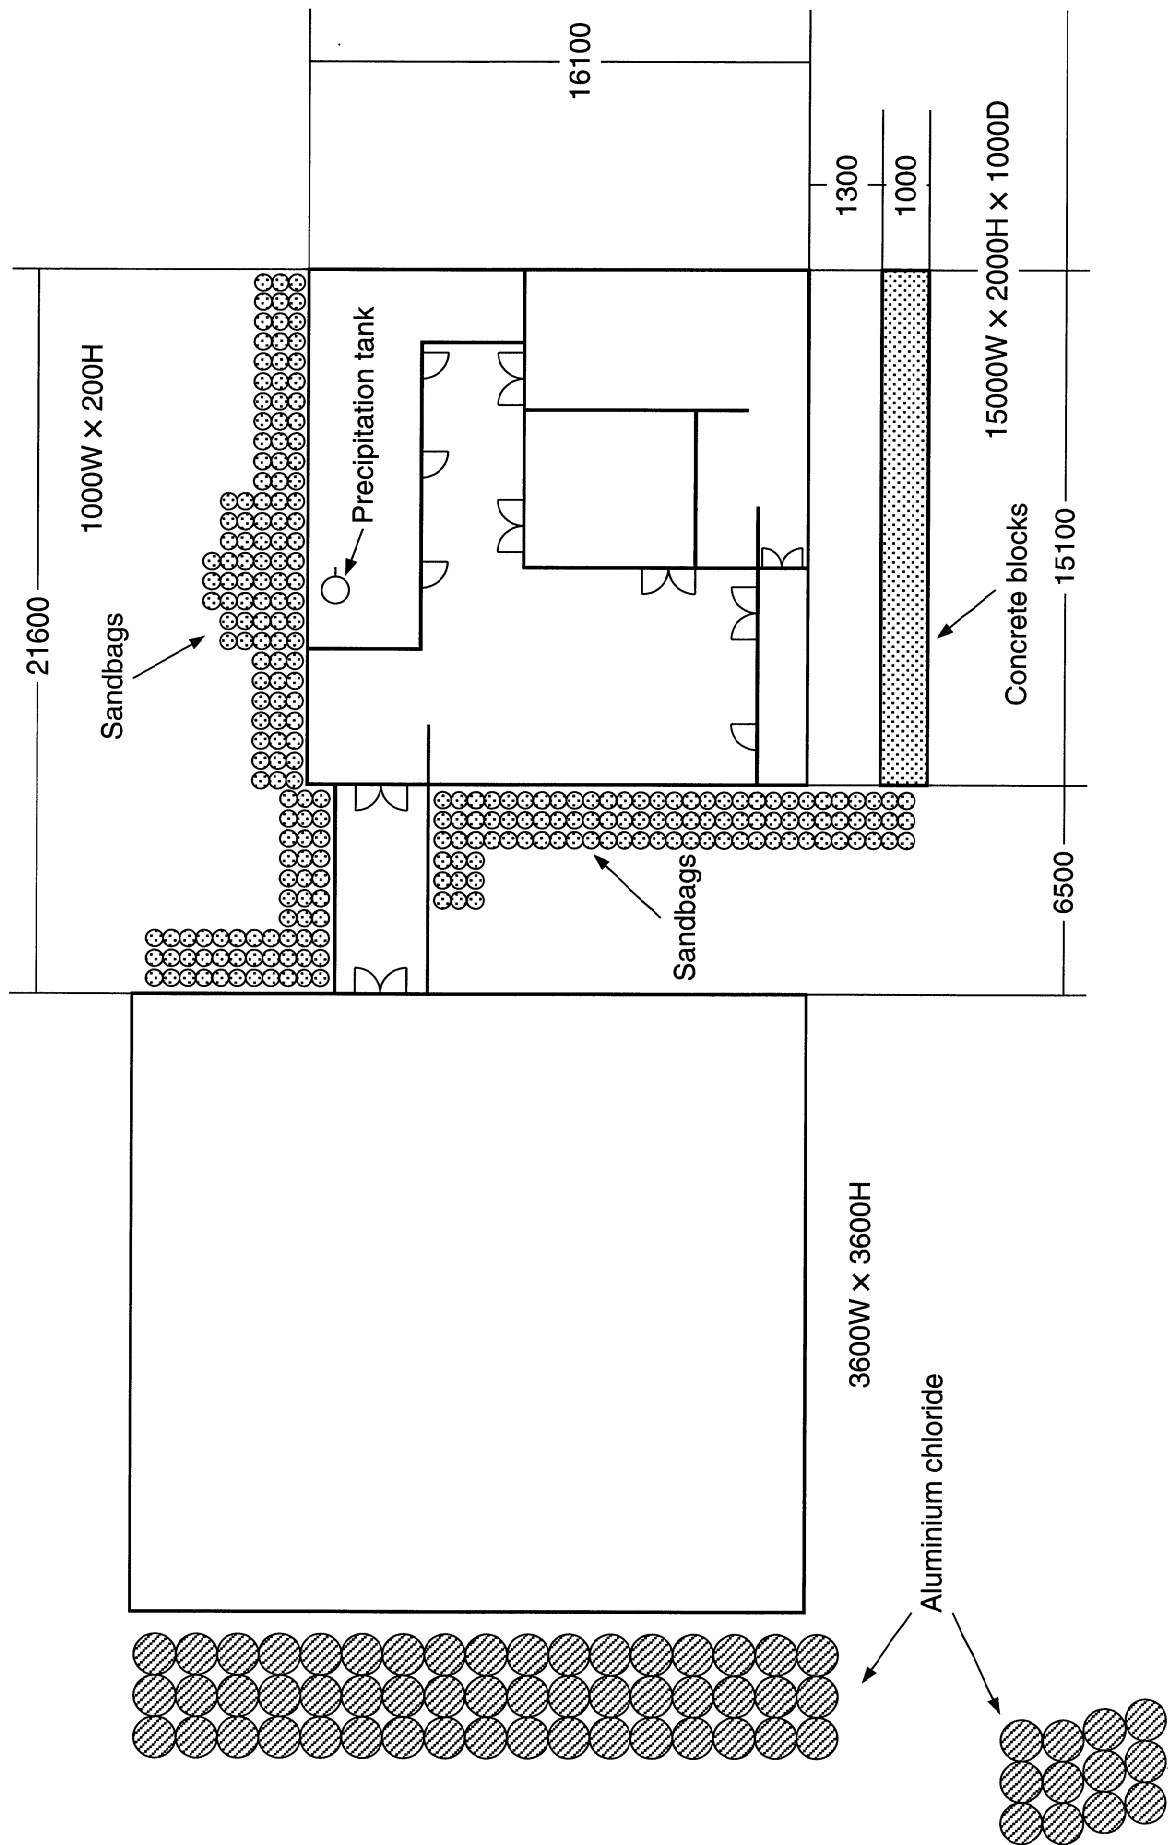
Fig. 13. Detailed plan of the conversion building indicating supplementary shielding arrangements (dimensions in mm).

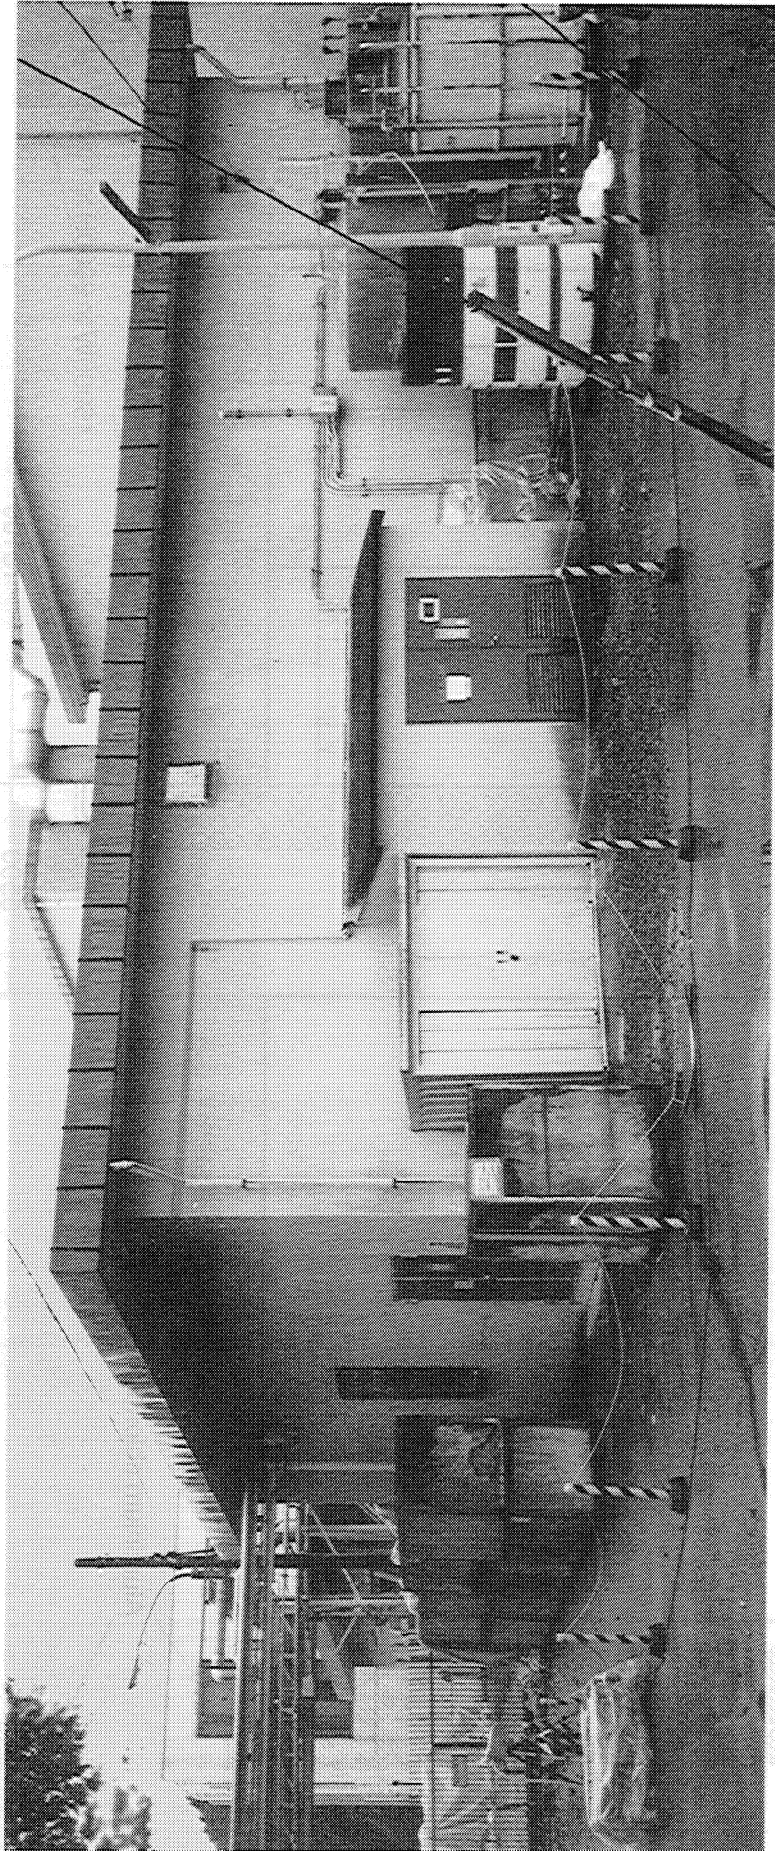
*Fig. 14. The conversion building with supplementary shielding in place.*

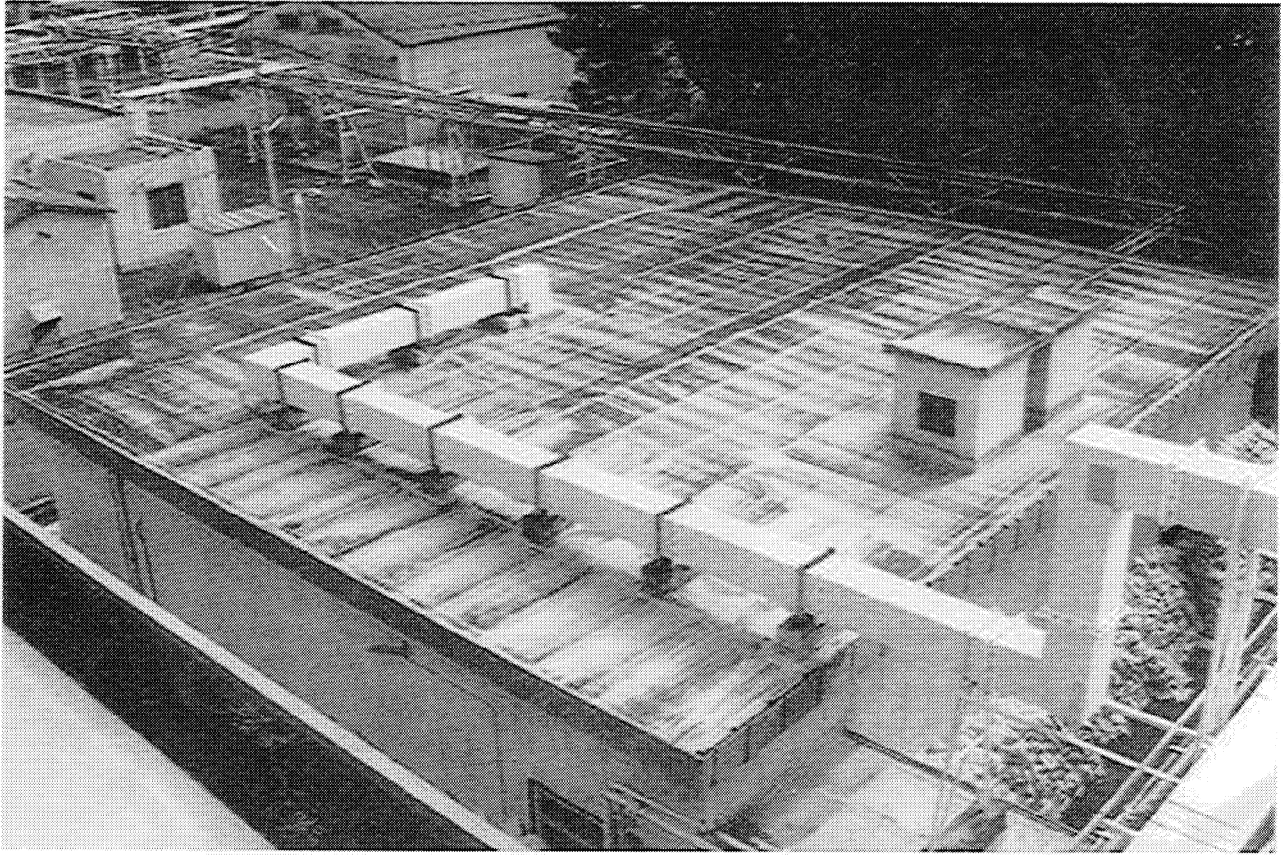
- With regard to radioactive releases, the operator reported that there had been no explosion in the building and there was no overpressure in the ventilation system. The visual check carried out by the workers who fed the boric acid into the precipitation tank showed that there had been no mechanical damage to the installation, and the integrity of the equipment, rooms and building in general had been maintained. During its mission, the IAEA Secretariat team observed that there was no apparent physical damage to the structural integrity of the conversion building. The team examined the roof of the conversion building from two opposite viewpoints (northwest and southeast) and confirmed that it in particular had not been damaged [14] (Fig. 15).

*Fig. 15. The roof of the conversion building.*

understanding of events and the corroboration of published material. The team was able to confirm independently that there was no apparent damage to the structural integrity of the JCO conversion building, and in particular that the roof appeared to be intact, and that gamma dose rate levels outside the JCO site were normal.

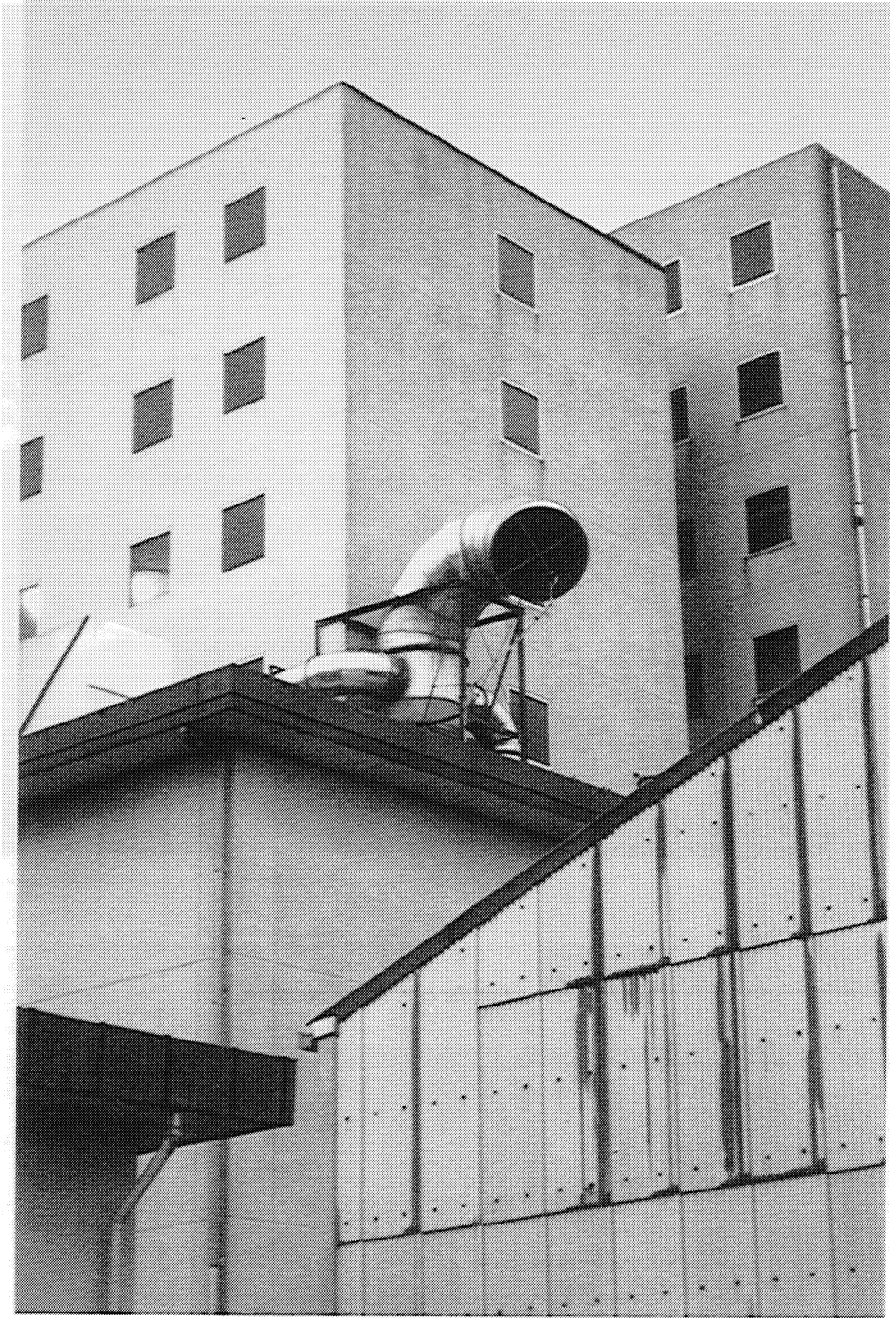
The high efficiency particulate air (HEPA) filters in the conversion building had filtered out particulates collected by the building's ventilation system, whose exhaust is connected to a general ventilation system that also serves other buildings. It had been reported by the workers who injected the boric acid into the precipitation vessel that an underpressure had been maintained, since air flow into the building was found. A smoke test on 5 October confirmed that there was an underpressure and that the ventilation system was working [14]. The integrity of the building confinement had therefore been provided primarily by active maintenance of an underpressure by the ventilation system and by the HEPA filters. However, owing to the detection of  $^{131}\text{I}$  released to the environment on the basis of exhaust point measurements (see Section 4.2.2) (Fig. 16), it was later decided to stop ventilation and to reinforce the passive confinement provided by the building.

*Fig. 16. The exhaust for the ventilation system.*

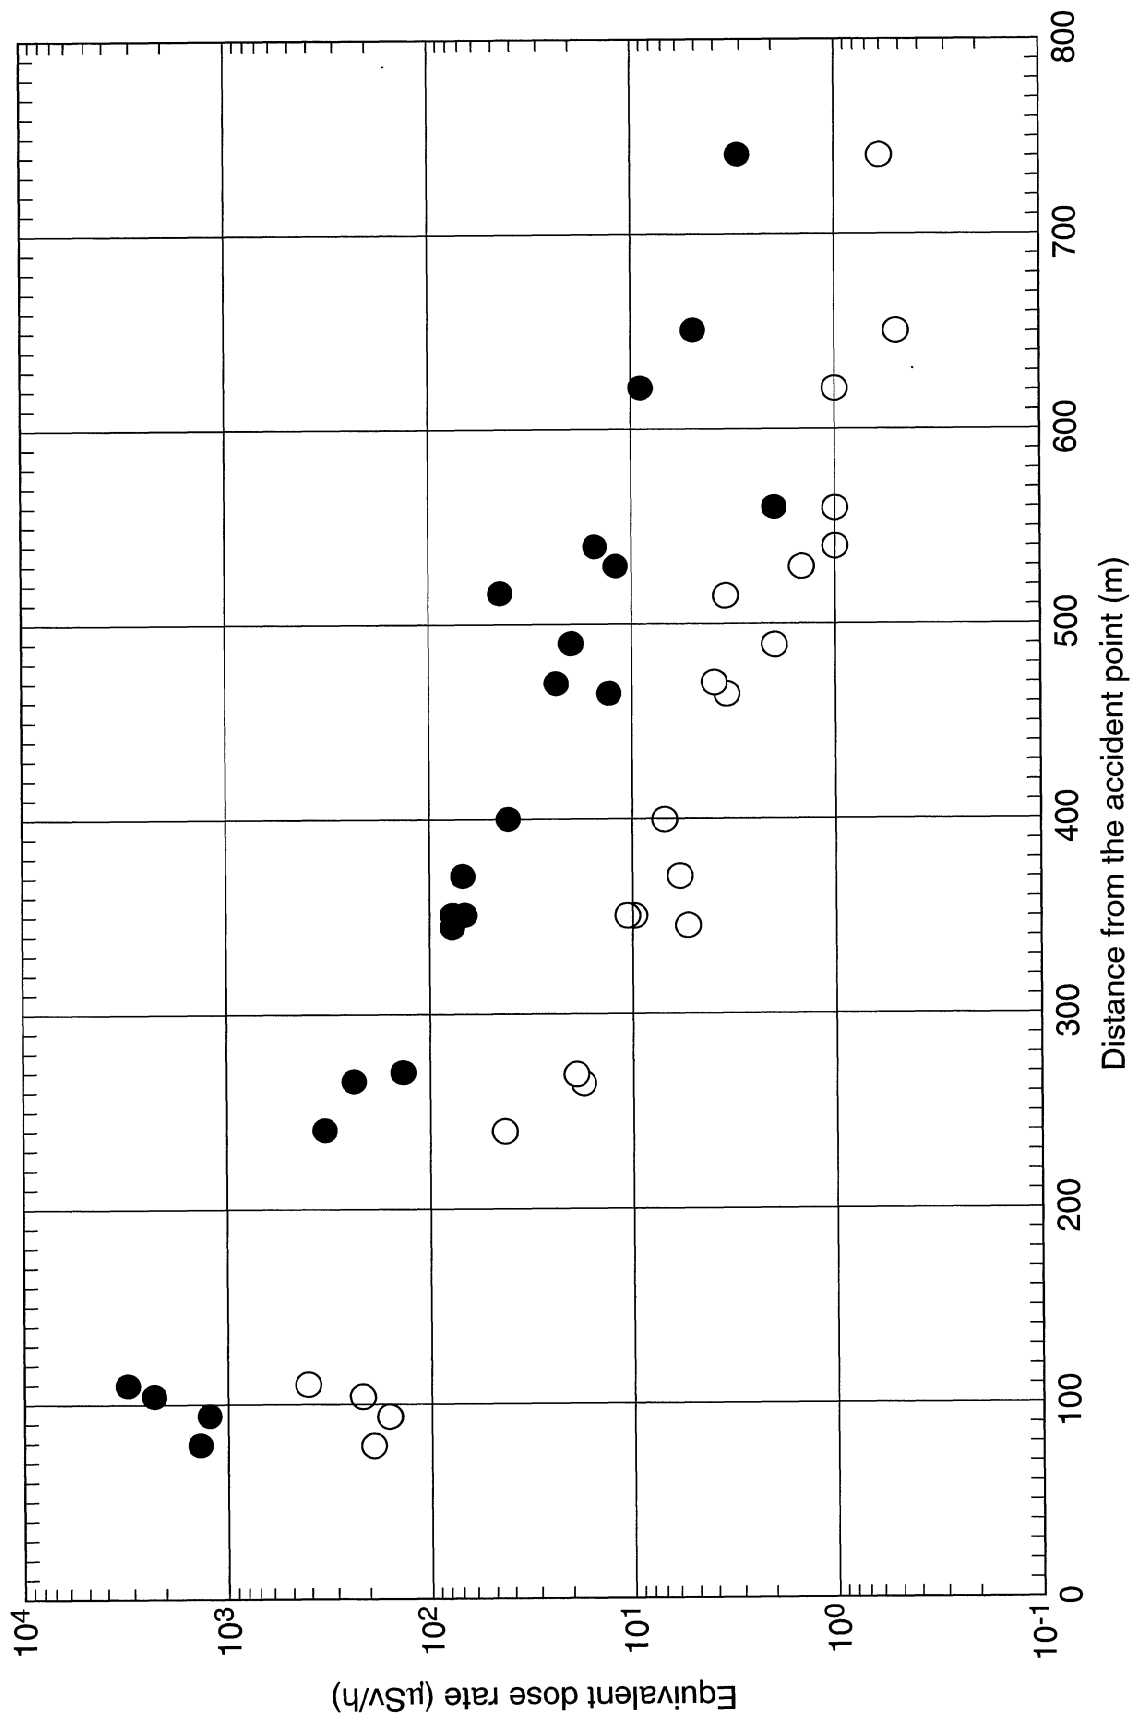
Fig. 17. Gamma and neutron equivalent dose rates around JCO at about 20:45 on 30 September 1999 at the monitoring posts indicated in Fig. 3 as a function of distance. (●: neutron; ○: gamma).
